NFPA Committee on Fire Apparatus FIREFIGHTER TREAD PLATE SLIP RESISTANCE STUDY

William Marletta, Ph.D., CSP

November 3, 1999

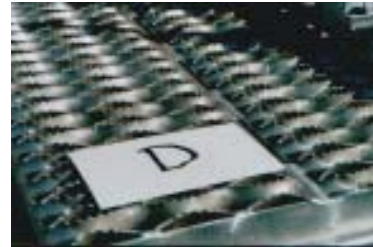
expressed concern that a fall on this type of surface could cause serious injury. Surface "D" was identified as Aluminum Grip Strut, an expanded metal, open surface design.

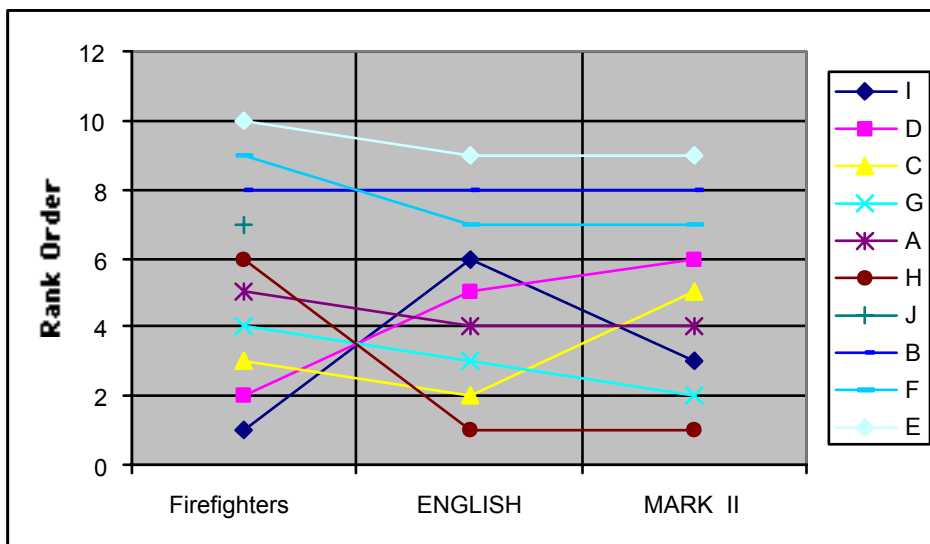
TABLE "H"

Rank Order Wet Comparisons Graph Firefighter/ Tester

Regarding the subjective evaluation of the firefighters, it is important to realize that the rank used for our comparison is an **average** of the 16 firefighters. For example, the total results of the firefighters rank order for milled smooth aluminum was reported as 1, 10, 10, 10, 10, 10, 10, 10, 10, 9, 10, 10, 10, 10, 10, 10, among the 16 firefighters. The average was a rank of 9.4 and the rank order was still 10 of 10 materials; however, clearly there was a question raised as to the first firefighters conclusion that the material was rank order #1, most slip resistant. Similarly, there is some variance raised in the firefighters rank order of the materials and some variances between firefighters are observed. However, overall there is a moderate to strong correlation between the testers and the firefighters.

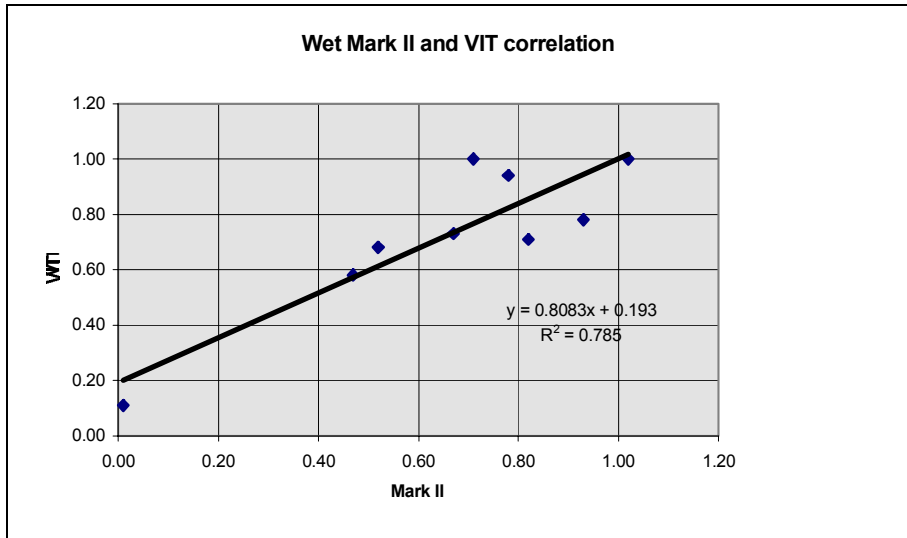
Table "R"

Pearson's correlation coefficient was calculated as 0.89. From a table lookup, this means we are 99% sure the agreement didn't happen by chance. If you square Pearson's correlation coefficient, you get a coefficient of determination of 0.79. This essentially means that about 79% of the information you get from using the Mark II is predicted by the VIT measurements.
